OV-1 MISHAP EXPERIENCE REPORT

FY 1972 through FY 1974

by
Mr. Paul R. Ewing

**Environmental Factors/Fixed Wing Division
Directorate for Aircraft Accident Analysis and Investigation**

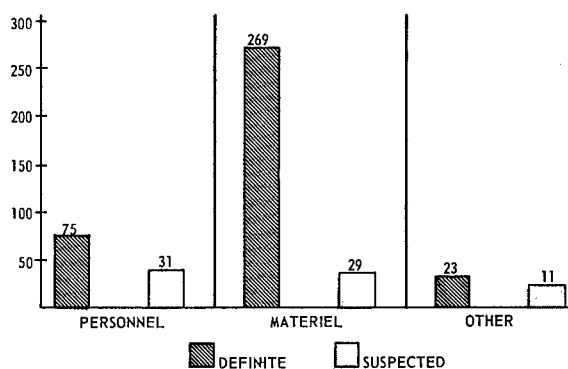
FIGURE 1.—Cause Factors for 376 Mishaps

Three hundred and sixty-seven definite and 71 suspected cause factors were recorded for the 376 mishaps reported. These are shown in figure 1. For the 58 damaging mishaps, 70 definite and 36 suspected cause factors were recorded (figure 2). A brief comparison of figures 1 and 2 reveals that although a majority

of mishaps involved materiel cause factors, personnel cause factors were predominant in the damaging mishaps.

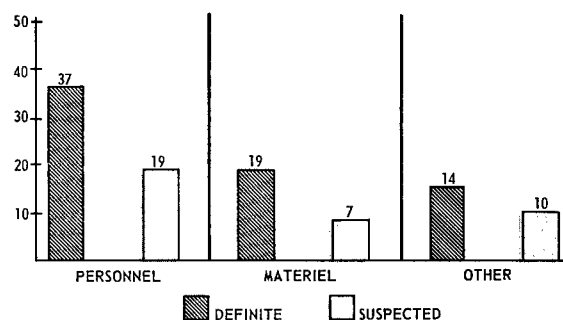
FIGURE 2.—Cause Factors for 58 Damaging Mishaps

Although materiel dominated the definite cause factors recorded for all mishaps (72%), personnel was recorded as the leading definite cause factor in damaging mishaps (53%). Twelve (21%) of the damaging mishaps accounted for \$13,436,402 (99%) of the damage and all of the injuries and fatalities. Materiel factors referenced in this report include failure of parts and components from all causes, i.e., prior over-stress, improper maintenance, etc.
